Priority Level: Medium — Recommended Action for Affected Systems		
Attention:	All Service Personnel	Bulletin: SB-028 Date: 1/16/2007
Products:	UltraPin™	
Issue:	Dot-Matrix Display (DMD) may be positioned too low.

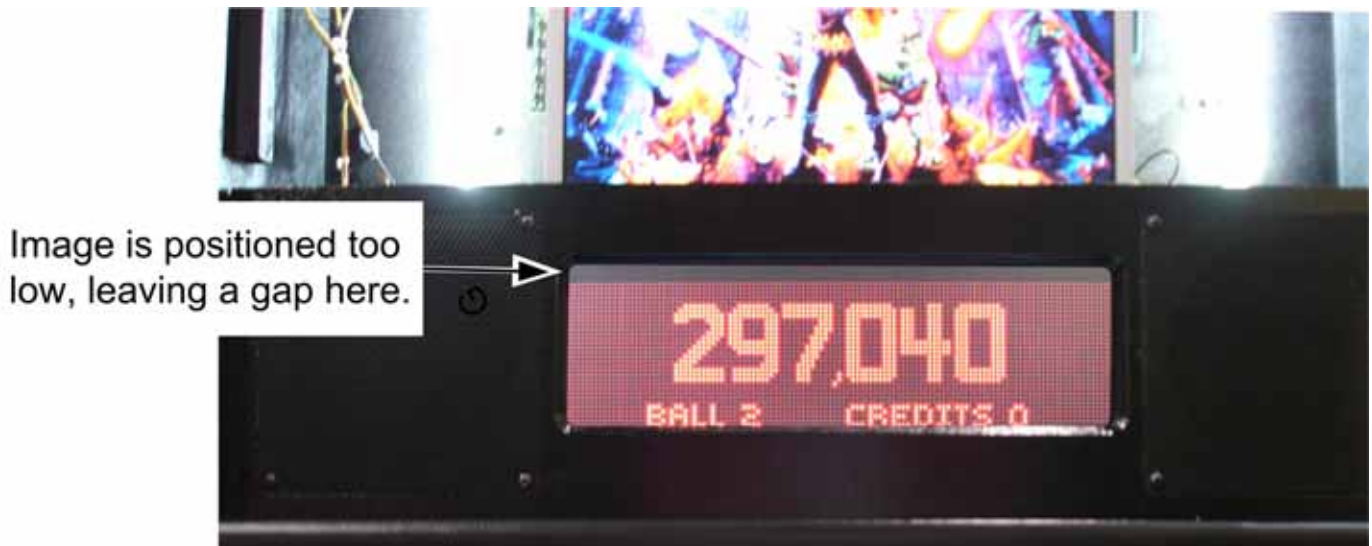
Symptom: If the image on the backglass monitor is positioned too low, you will see a black gap above the Dot-Matrix Display (DMD), as shown below.

Dot Matrix Display out of Adjustment

Solution: Follow the steps in this document to reposition the DMD image on your backglass monitor.

1. Remove the three (3) screws from the upper retaining bracket above the backglass, and remove the retaining bracket and glass.

2. Use the Monitor Remote Control Board, located to the left of the backglass monitor, to reposition the image. See the step-by-step procedure on page 2 of this bulletin.

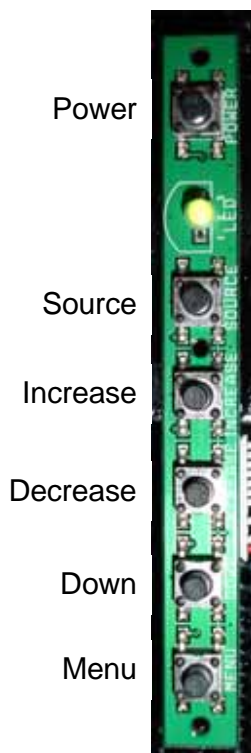
*Monitor Remote
Control Board*

Refer to the figure below and use the buttons on the monitor remote control board to perform the following steps:

1. Press **Menu** once to open the Monitor Adjustment Menu.
2. Press **Decrease** once.
3. Press **Menu** twice. The Picture Adjustment Menu, shown below, will appear onscreen.
4. Press **Decrease** repeatedly to change the setting for **H. Position** to **35**.
(Press **Increase** if you need to increase the value.)
5. Press **Down** repeatedly until you exit from the Monitor Adjustment Menu.

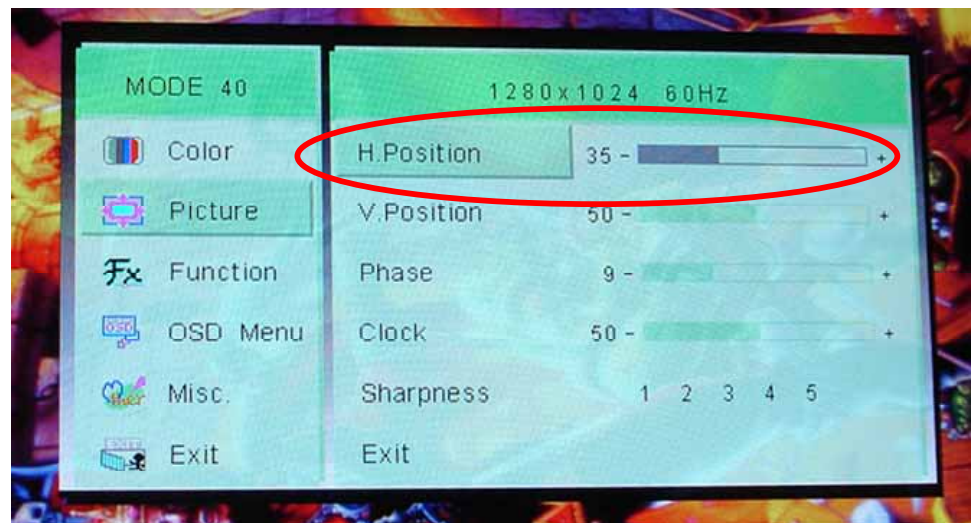
Picture Adjustment Menu
