Service Bulletin

Priority Level: Low — Useful Information		
Attention:	All Service Personnel	**Bulletin:** SB-032 **Date:** 2/7/2007
Products:	*Need for Speed*™ **Underground**	
Issue:	Shifters need adequate slack in micro switch wires.

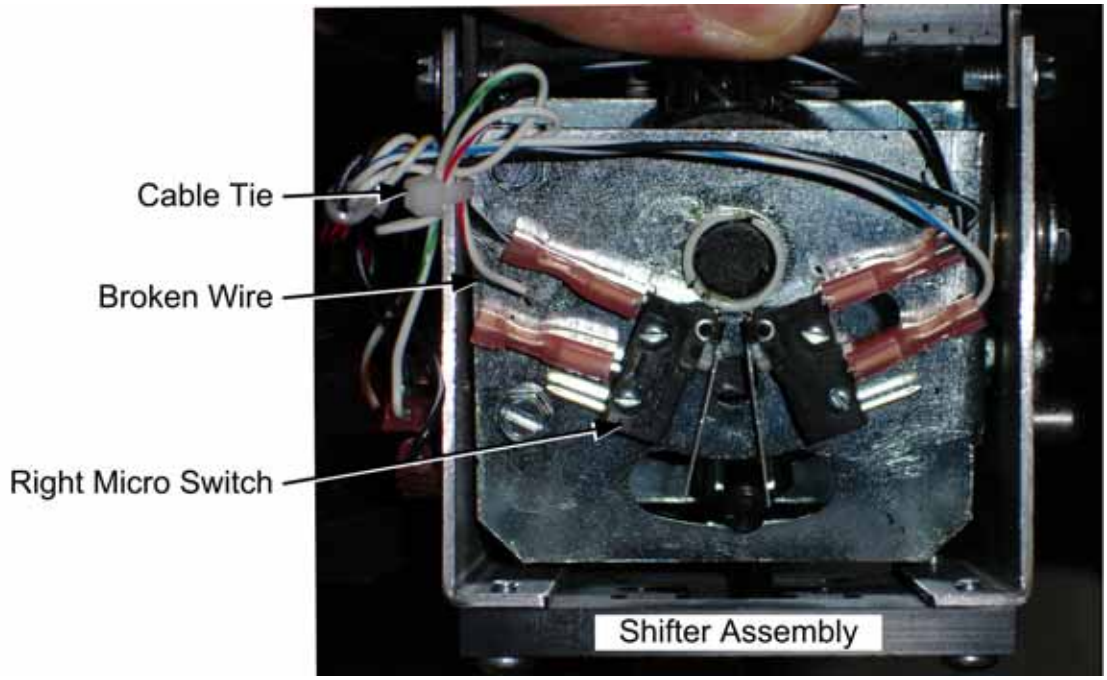
Symptom: Some six-speed shifters were shipped with wires tied too tightly near the micro switches. This can cause the wires to the *Right* micro switch to break, causing the shifter to malfunction in gears 5 and 6.

Shifter Assembly with Broken Micro Switch Wire

1. Remove the four (4) T-10H Torx® Security screws from the top of the shifter assembly and carefully lift the shifter assembly out of the housing.
2. Inspect the wires while moving the shifter left to right, and make sure there is some slack in the wires between the cable tie and the switch terminals.
3. If necessary, snip the cable tie and re-tie it so that there is adequate slack in the wire.
4. If the wire has broken, splice it to a new spade connector and make sure there is adequate slack in the wire when you connect it to the micro switch.
